NSW Site Auditor Scheme

Site Audit Statement

Site audit statement no. *JC-NSW26b*

Address: *IASB Addition, Randwick Campus Redevelopment Site, bound by*

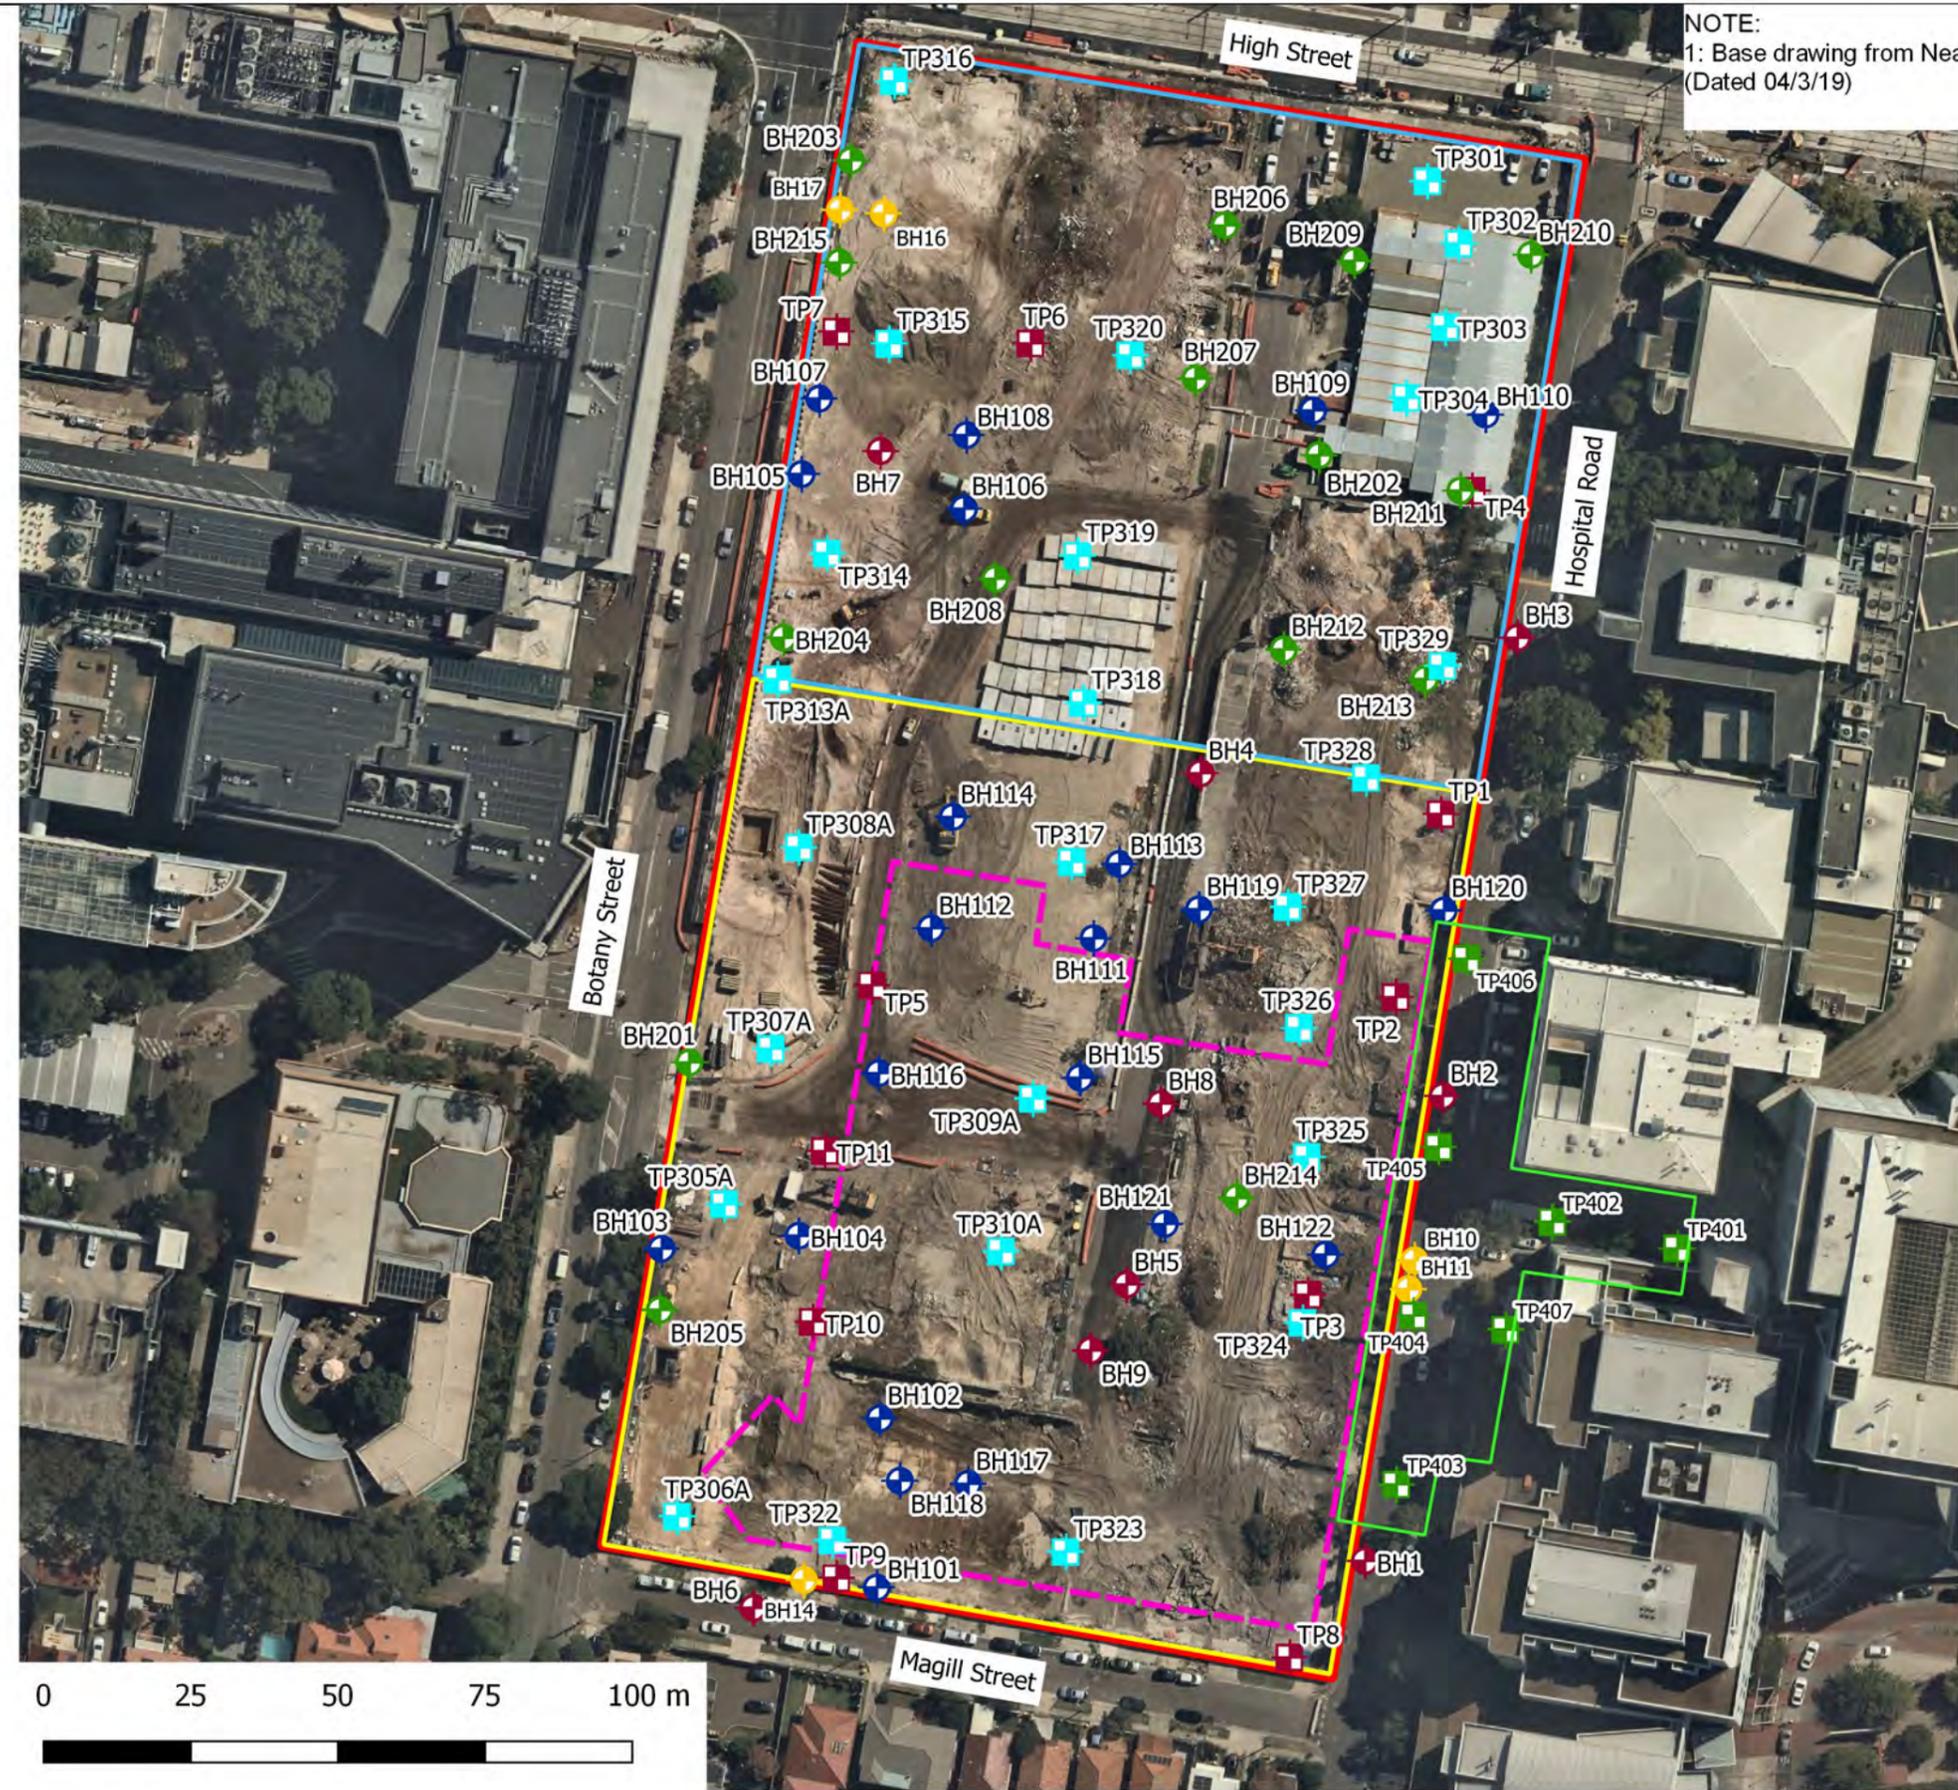
- Post Demolition Test Pit (Current Investigation)
- DP Borehole Location (June, 2018)
- DP Borehole Location (Oct. 2017)
- DP Environmental Borehole (Jan. 2018)
- DP Test Pit Location (Aug. 2018)
- IASB Addition Test Pits (Aug. 2019)
- Existing Groundwater Wells

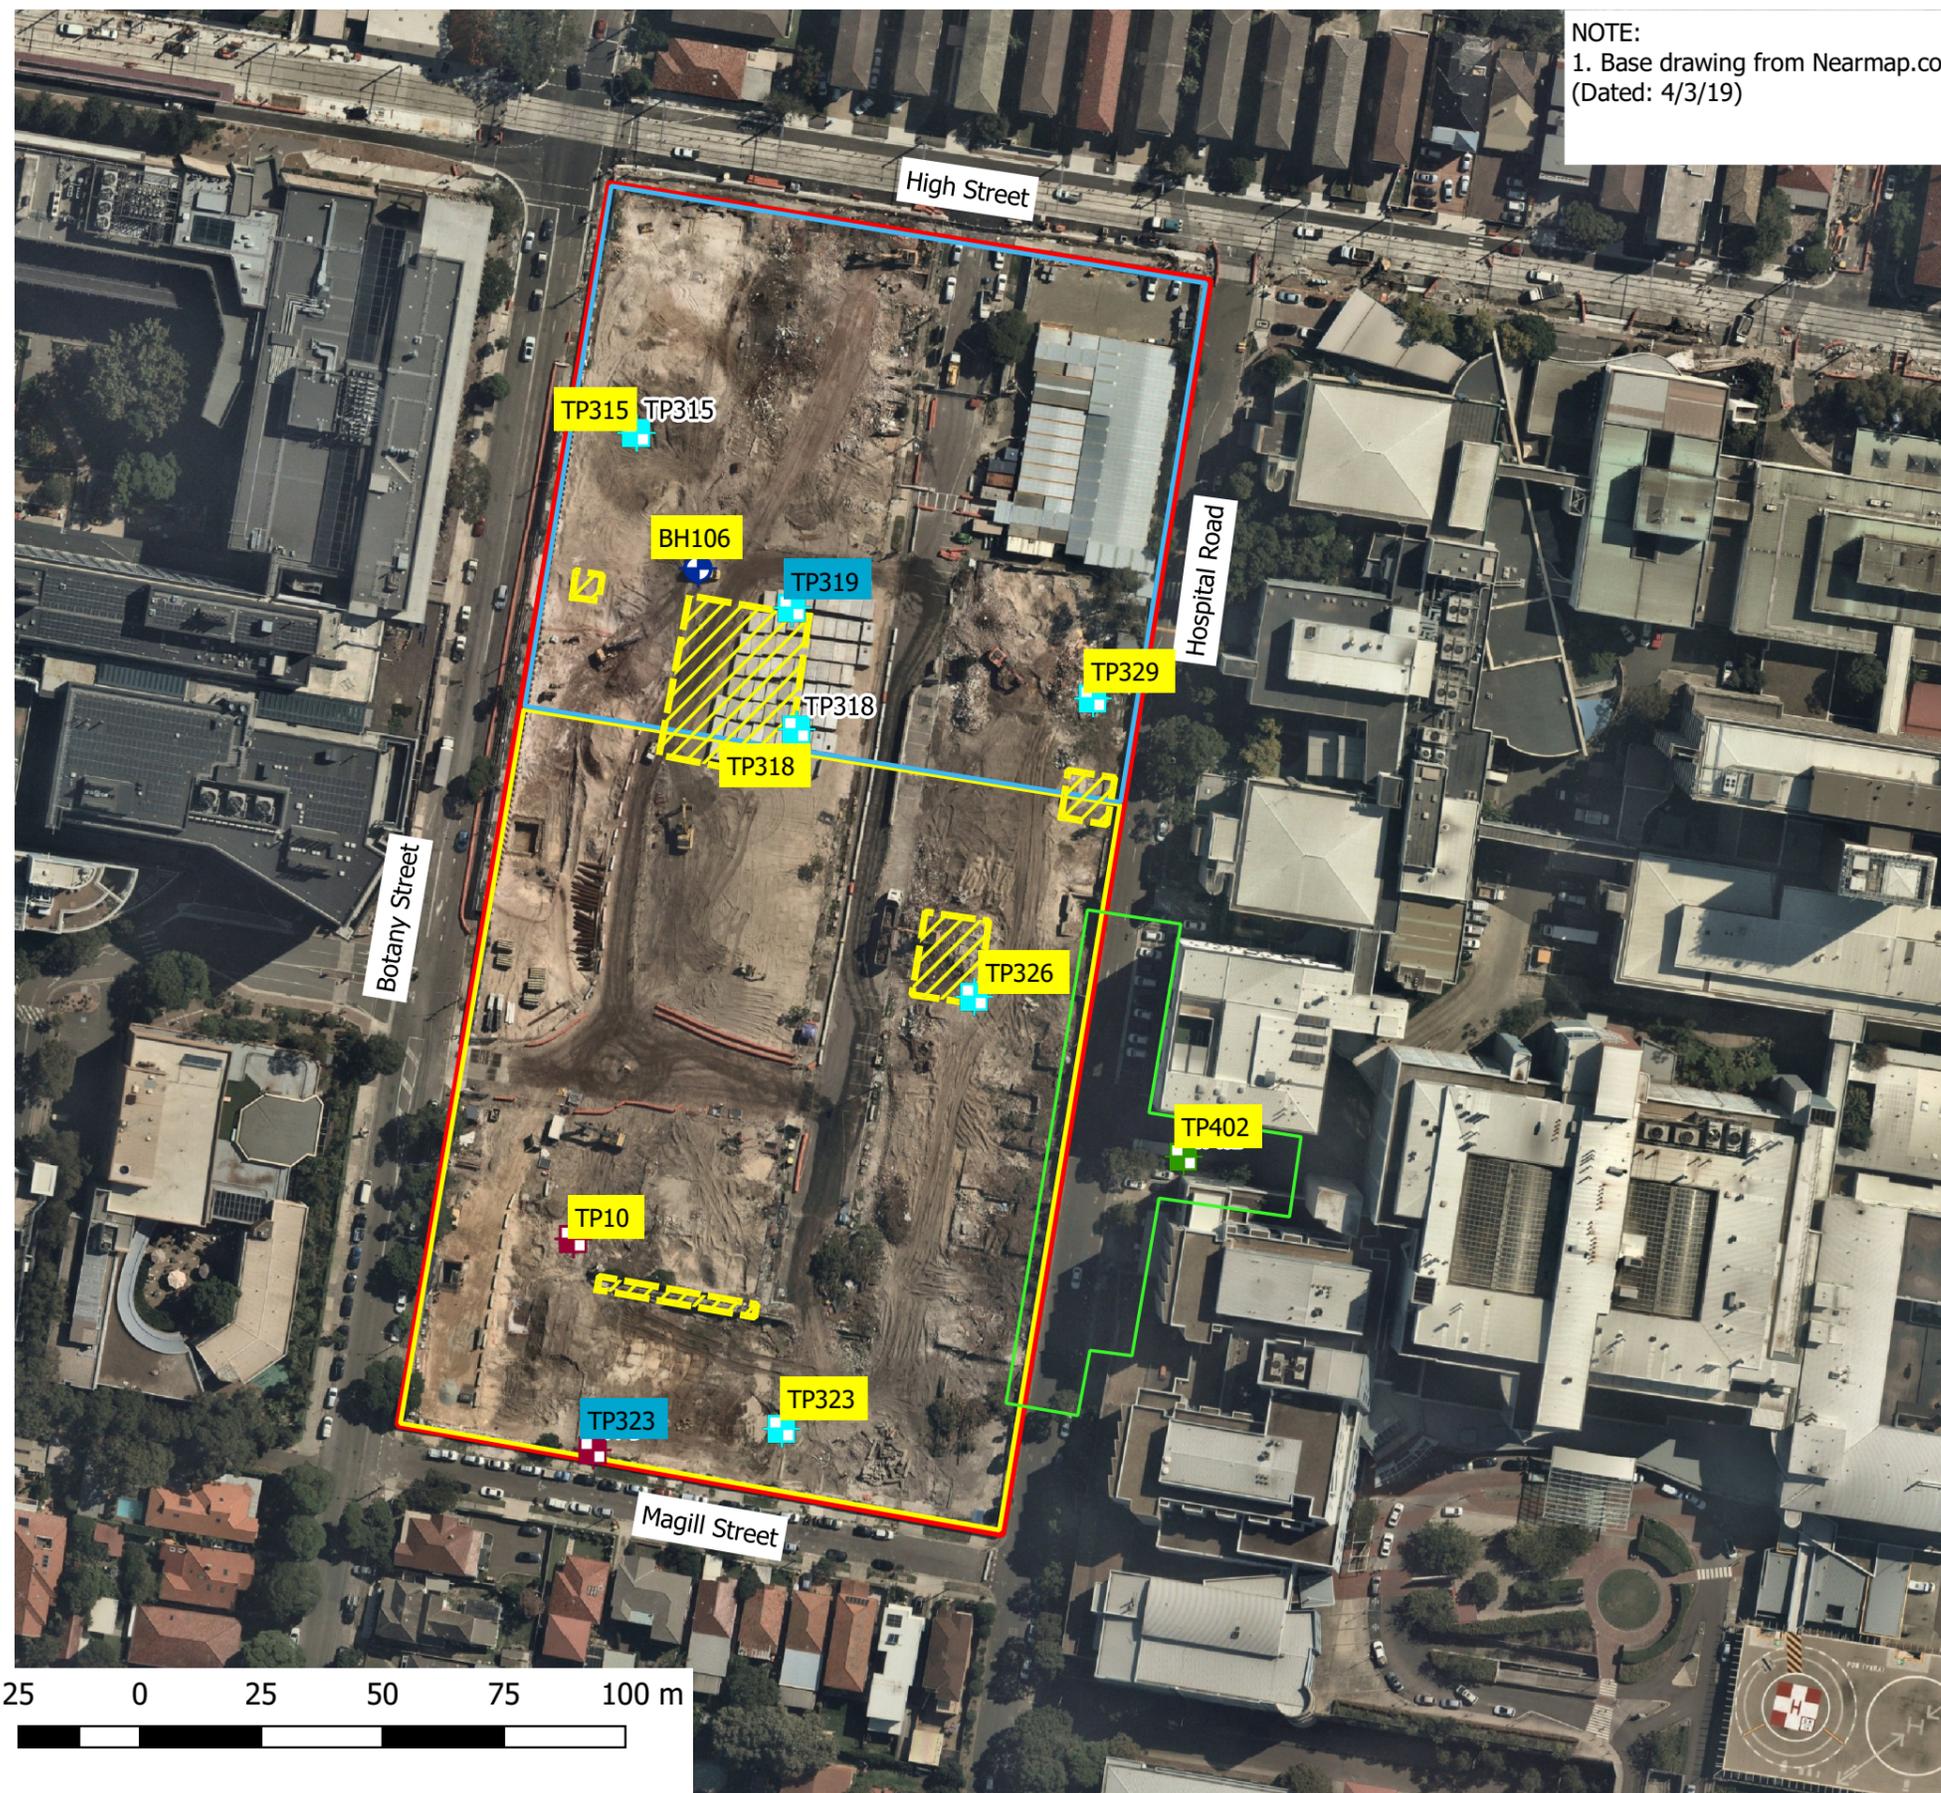
- Greater RCR Boundary
 - Stage 1 Boundary
 - Stage 2 Boundary
 - Approximate Observed Surface ACM Areas
 - IASB Addition
- Test Locations in which ACM was observed
- Post Demolition Test Pit (Current Investigation)
 - DP Environmental Borehole (Jan. 2018)
 - DP Test Pit Location (Aug. 2018)
 - IASB Addition Test Pit Location (Aug. 2019)
 - ACM observed at test location/during seiving (0-0.25m depth), between 9/1/2018 and 13/2/2019
 - ACM observed at test location/during seiving (0.4-0.5m depth), between 8/8/2018 and 11/2/2019

- Individual suspected asbestos containing material (ACM) fragments were located in BH106, TP 315, 318, 326, 329 at a depth of 0.0 – 0.2 m and TP10 at a depth of 0.0 - 0.1 m. Additionally, ACM was observed in TP9 and TP319 at a depth of 0.4 - 0.5 m. The locations where ACM was located either through visual observation or during sieving of 10L samples is indicated on Drawing 2 (Appendix A);

- Surficial ACM was observed at multiple locations in between test locations as indicated on Drawing 2 (Appendix A);
- All PID readings were <3 ppm; and

The observed asbestos impacts are shown on Drawing 2, Appendix A, whilst the benzo(a)pyrene impacts are shown on Drawing 3, Appendix A.

- A qualified occupational hygienist will inspect the surface for potential bonded ACM and issue a clearance certificate;
- Where bonded ACM is observed on the ground surface elsewhere (e.g. as shown on Drawing 2, Appendix A), a licensed asbestos contractor will remove and double bag the bonded ACM and a qualified occupational hygienist will prepare a clearance report;

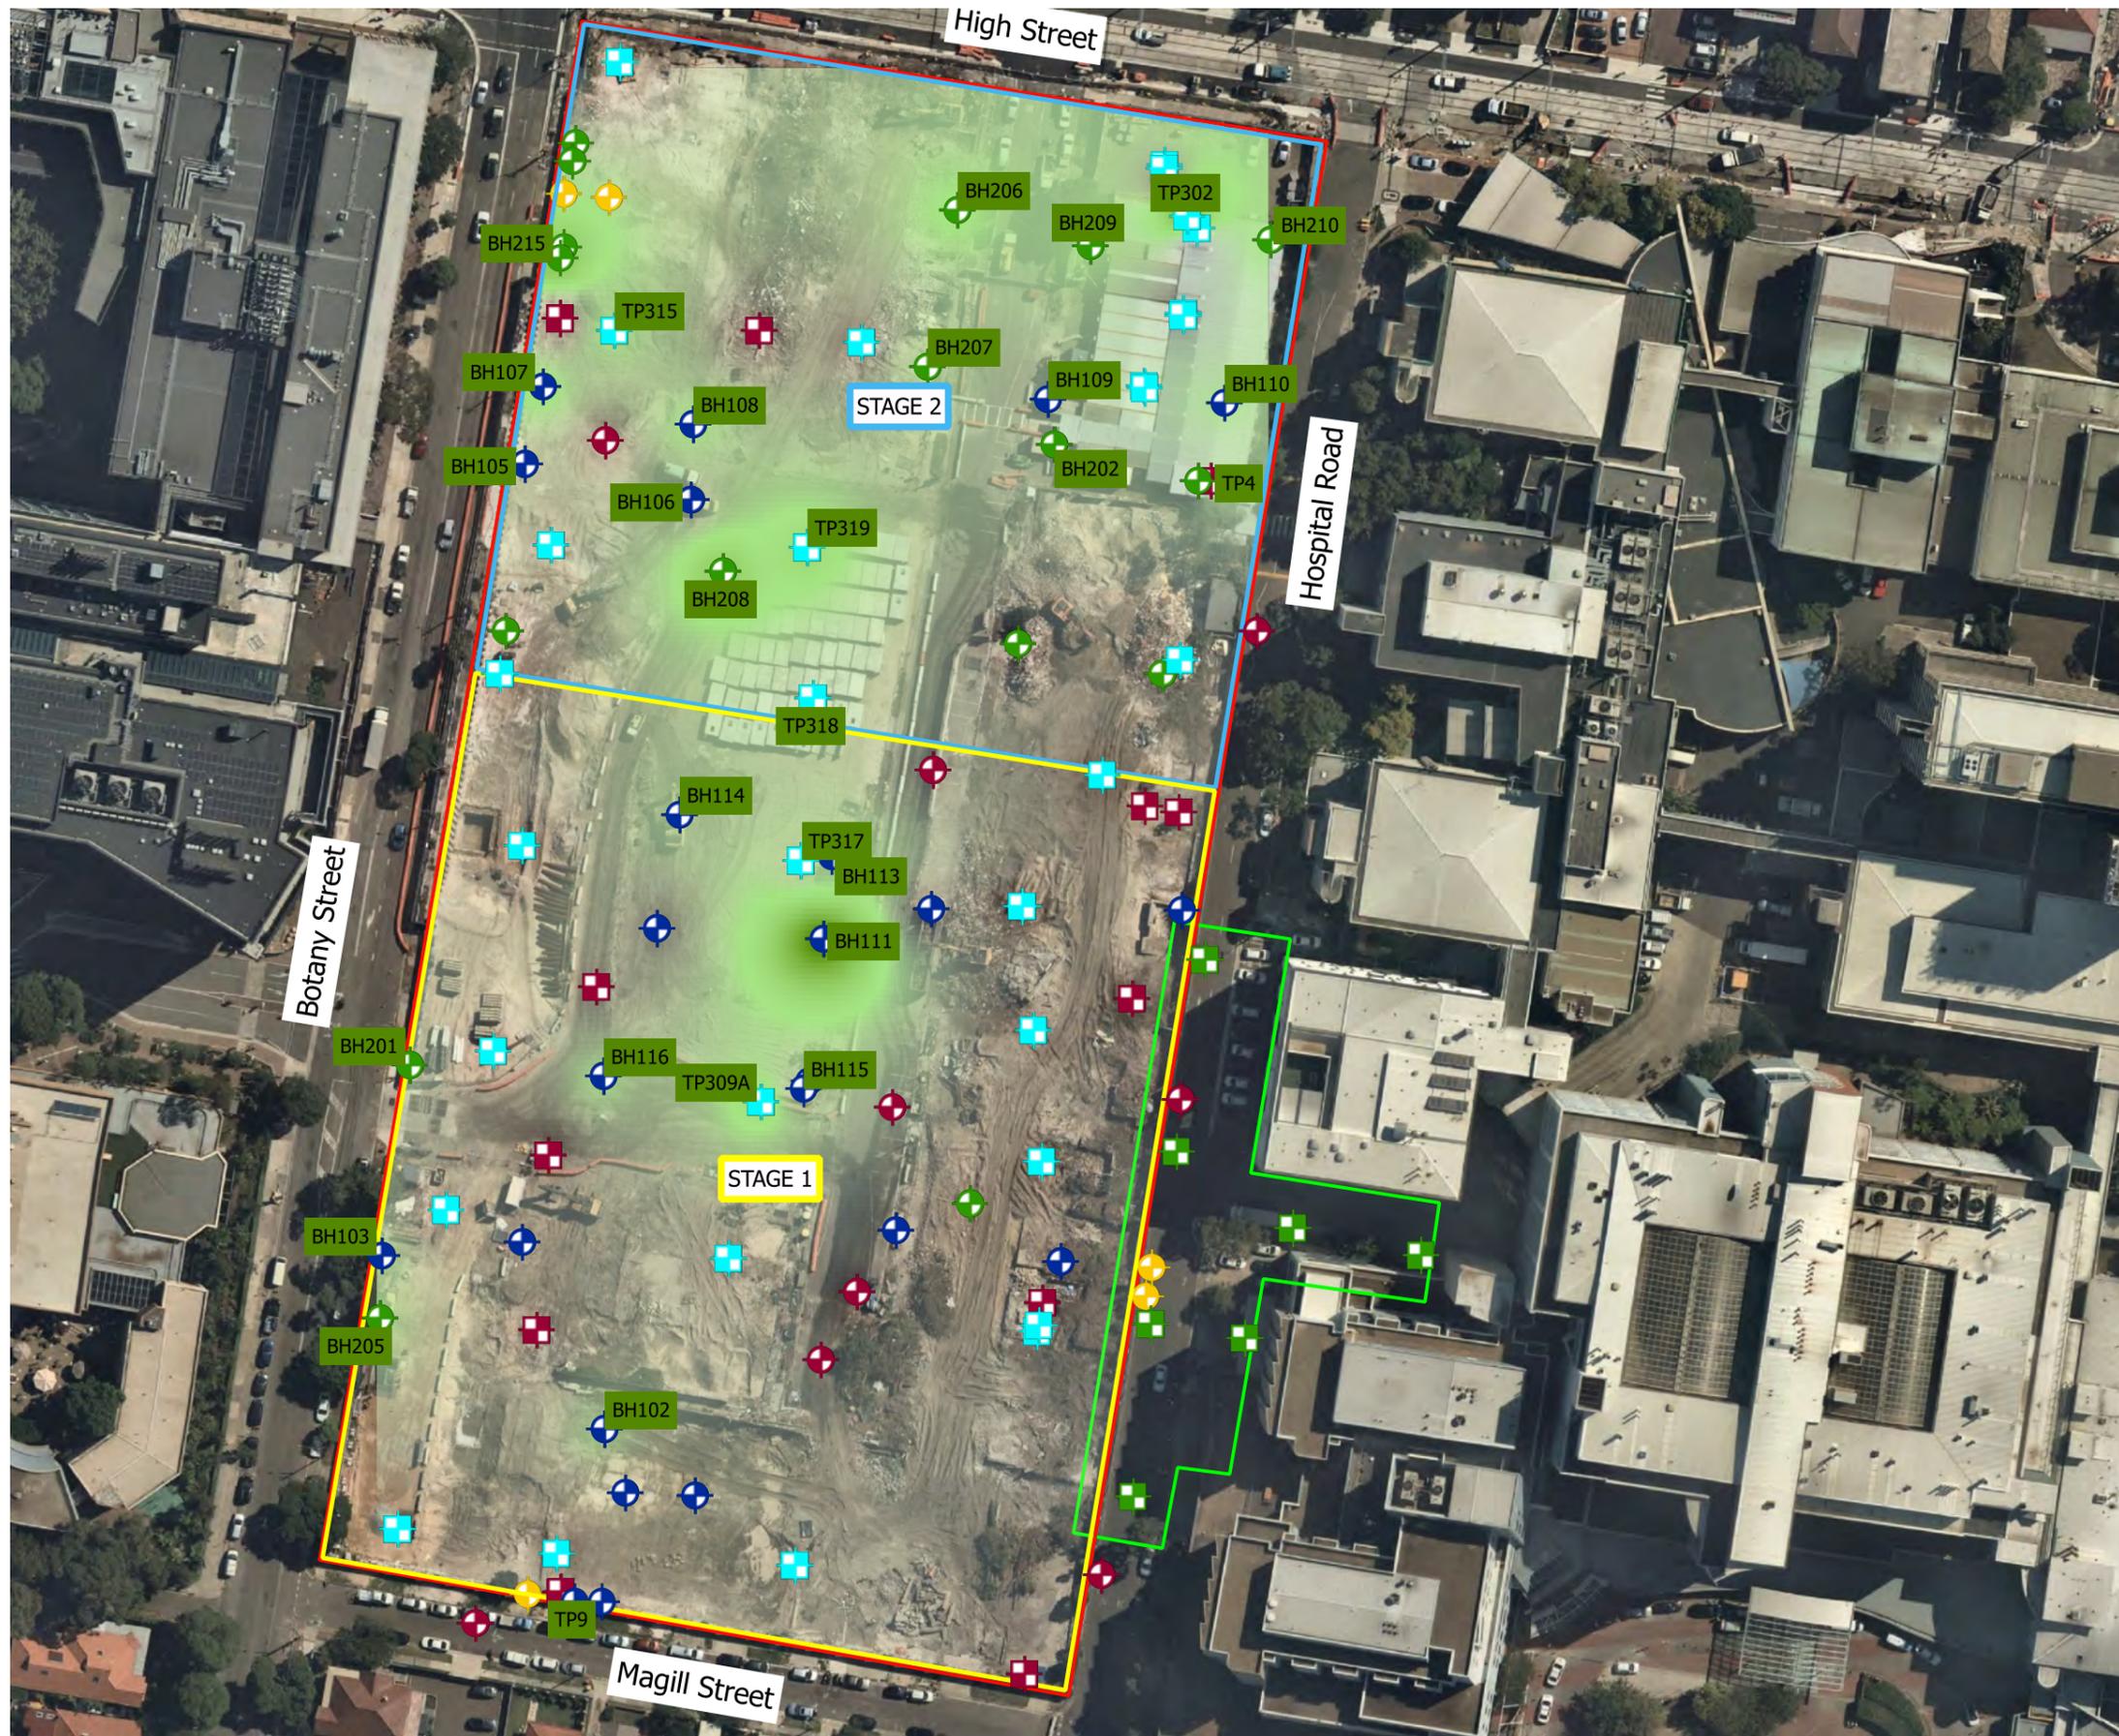
NOTE:
 1: Detected B(a)P concentrations for soils up to 1 m depth
 2: Interpolation of concentrations between test locations is approximate only

- Test Locations**
- Post Demolition Test Pit (Current Investigation)
 - DP Test Tit Location (Aug. 2018)
 - DP Environmental Borehole (Jan. 2018)
 - DP Borehole Location (Oct. 2017)
 - DP Borehole Location (June, 2018)
 - IASB Addition Test Pit Locations (Aug. 2019)
 - Existing Groundwater Well
 - B(a)P Detected Above 0.7 mg/kg

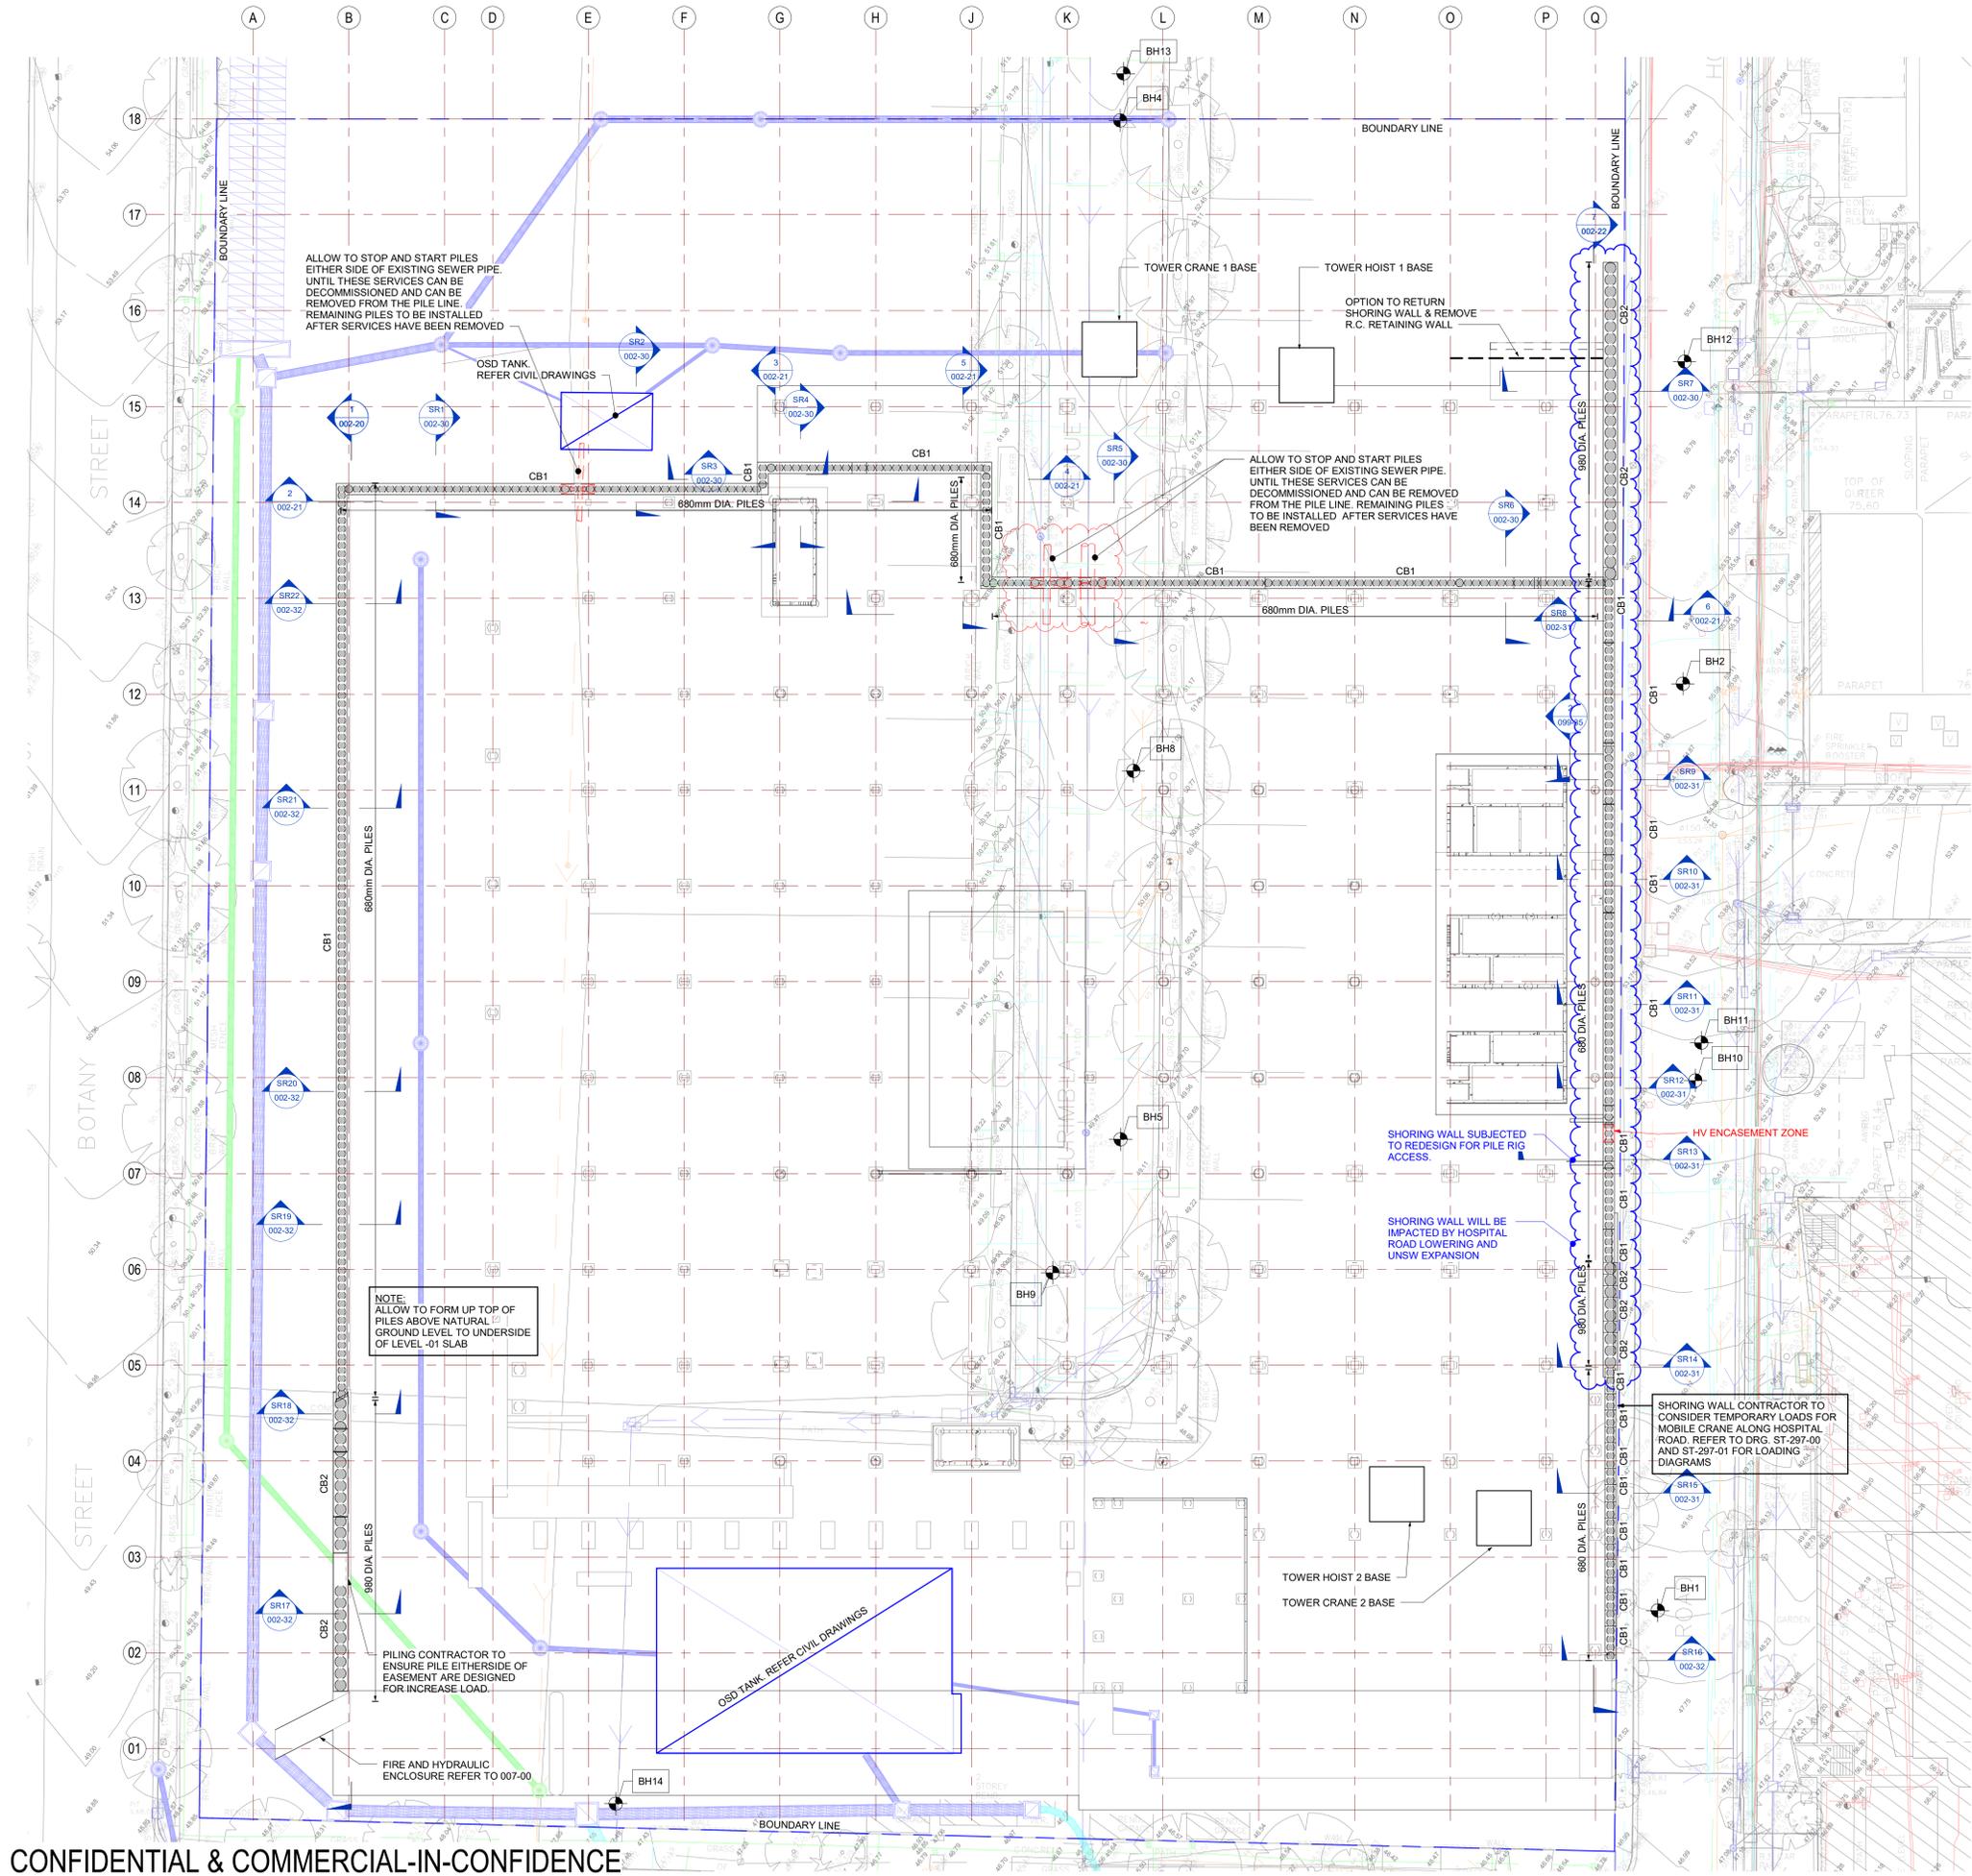
DRAWING NUMBER
ISSUE
RCR-ENS-STR-50-DRW-002-00 2

DRAWING
BUILDING 50
SITE RETENTION GENERAL ARRANGEMENT

SITE RETENTION - GENERAL ARRANGEMENT

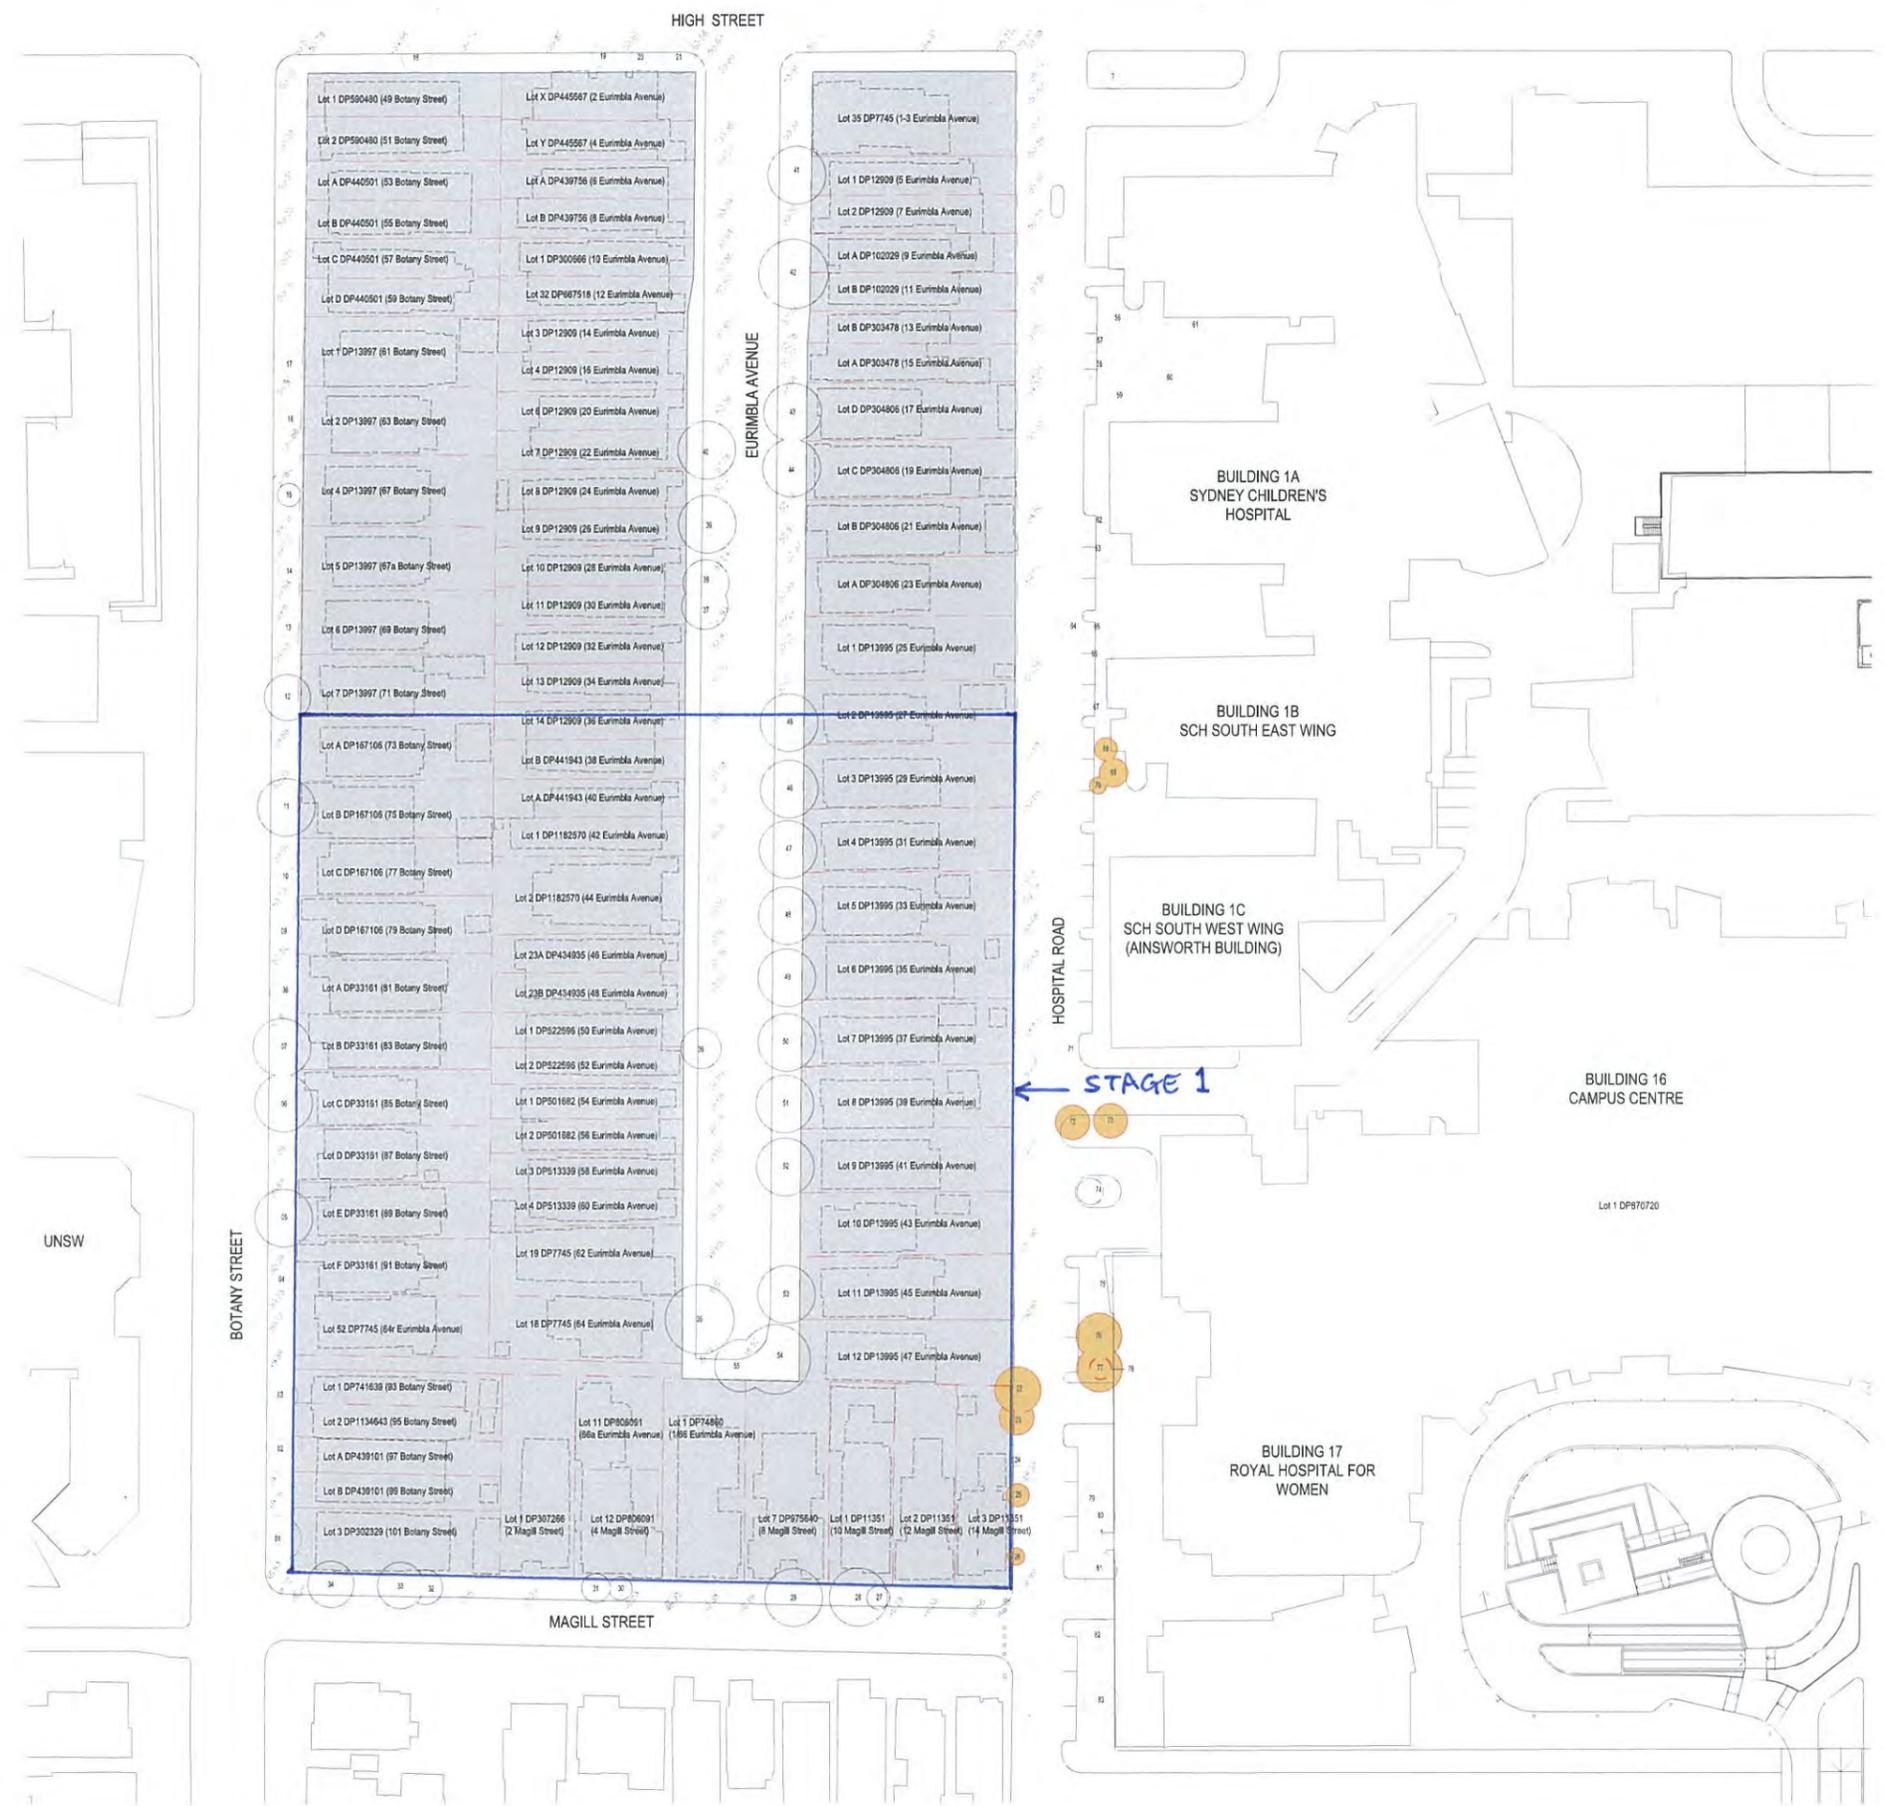
DRAWING
 DEMOLITION PLAN - DEVELOPMENT APPLICATION
 RCR-BVN-AR-00-DWG- U1-XX-03
 ISSUE
 A

- REMOVE ALL TREES WITHIN SITE (NOT DRAWN)
- EXISTING SITE BOUNDARIES
- EXISTING STRUCTURES TO BE DEMOLISHED
- TREES TO BE REMOVED - LOCATED ON EXISTING HOSPITAL CAMPUS
- EXISTING TREES

NOTE 1: DEVELOPMENT APPLICATION COVERS AREA SHOWN GREY AND TREES SHOWN IN ORANGE.

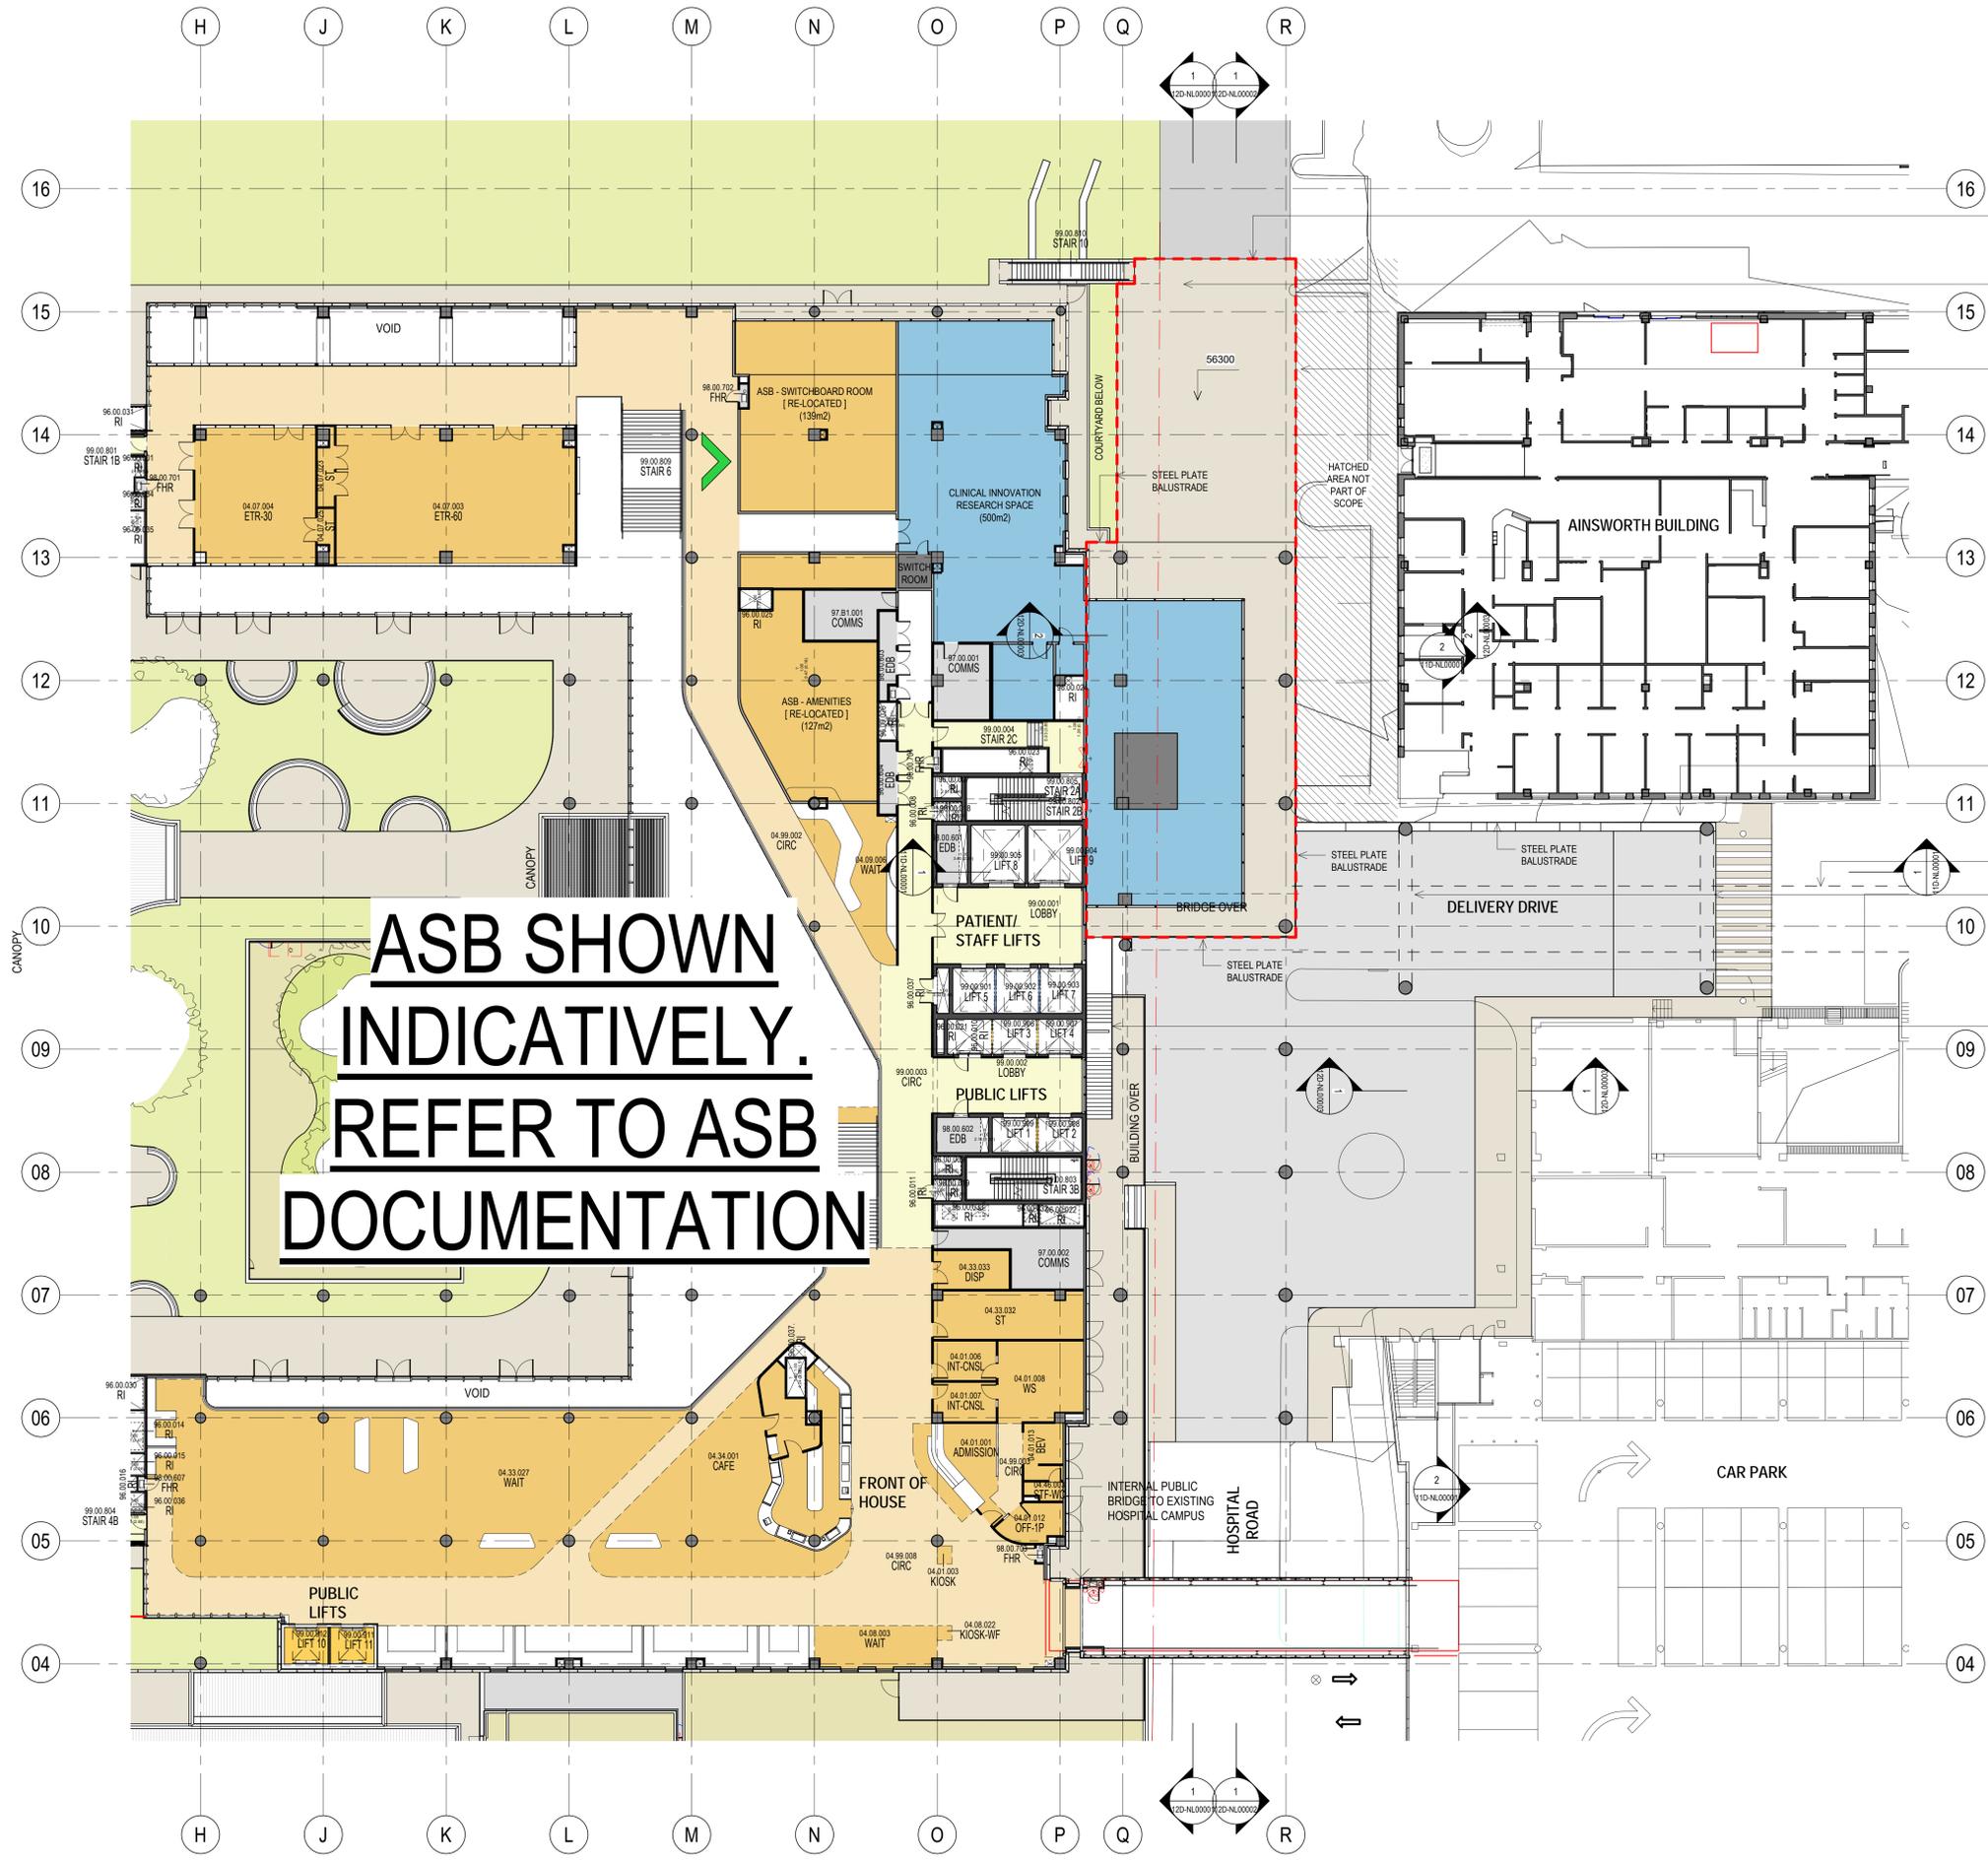
HOSPITAL ROAD WORKS - LEVEL 00
RCR-BVN-ARC-00-DRAW-11B-0000001

- EXTENT OF EXISTING HOSPITAL ROAD. ALLOW TO MODIFY EXISTING LEVELS AS REQUIRED TO MEET NEW DECK
- ALLOW FOR CRANE ACCESS FOR FUTURE MRI REPLACEMENT
- DASHED RED LINE INDICATES EXTENT OF NEW SLAB AT LEVEL 00. READ IN CONJUNCTION WITH EAST INTEGRATION DRAWINGS
- EXISTING FOOTPATH RETAINED
- BRIDGE OVER
- PERMANENT BRIDGE SUPPORTS
- NEW STAIR, HANDRAIL AND STEEL PLATE BALUSTRADE

**ASB SHOWN
INDICATIVELY.
REFER TO ASB
DOCUMENTATION**
