NSW Site Auditor Scheme

Site Audit Statement

Site audit statement no. *JC-NSW26b*

Address: *IASB Addition, Randwick Campus Redevelopment Site, bound by*

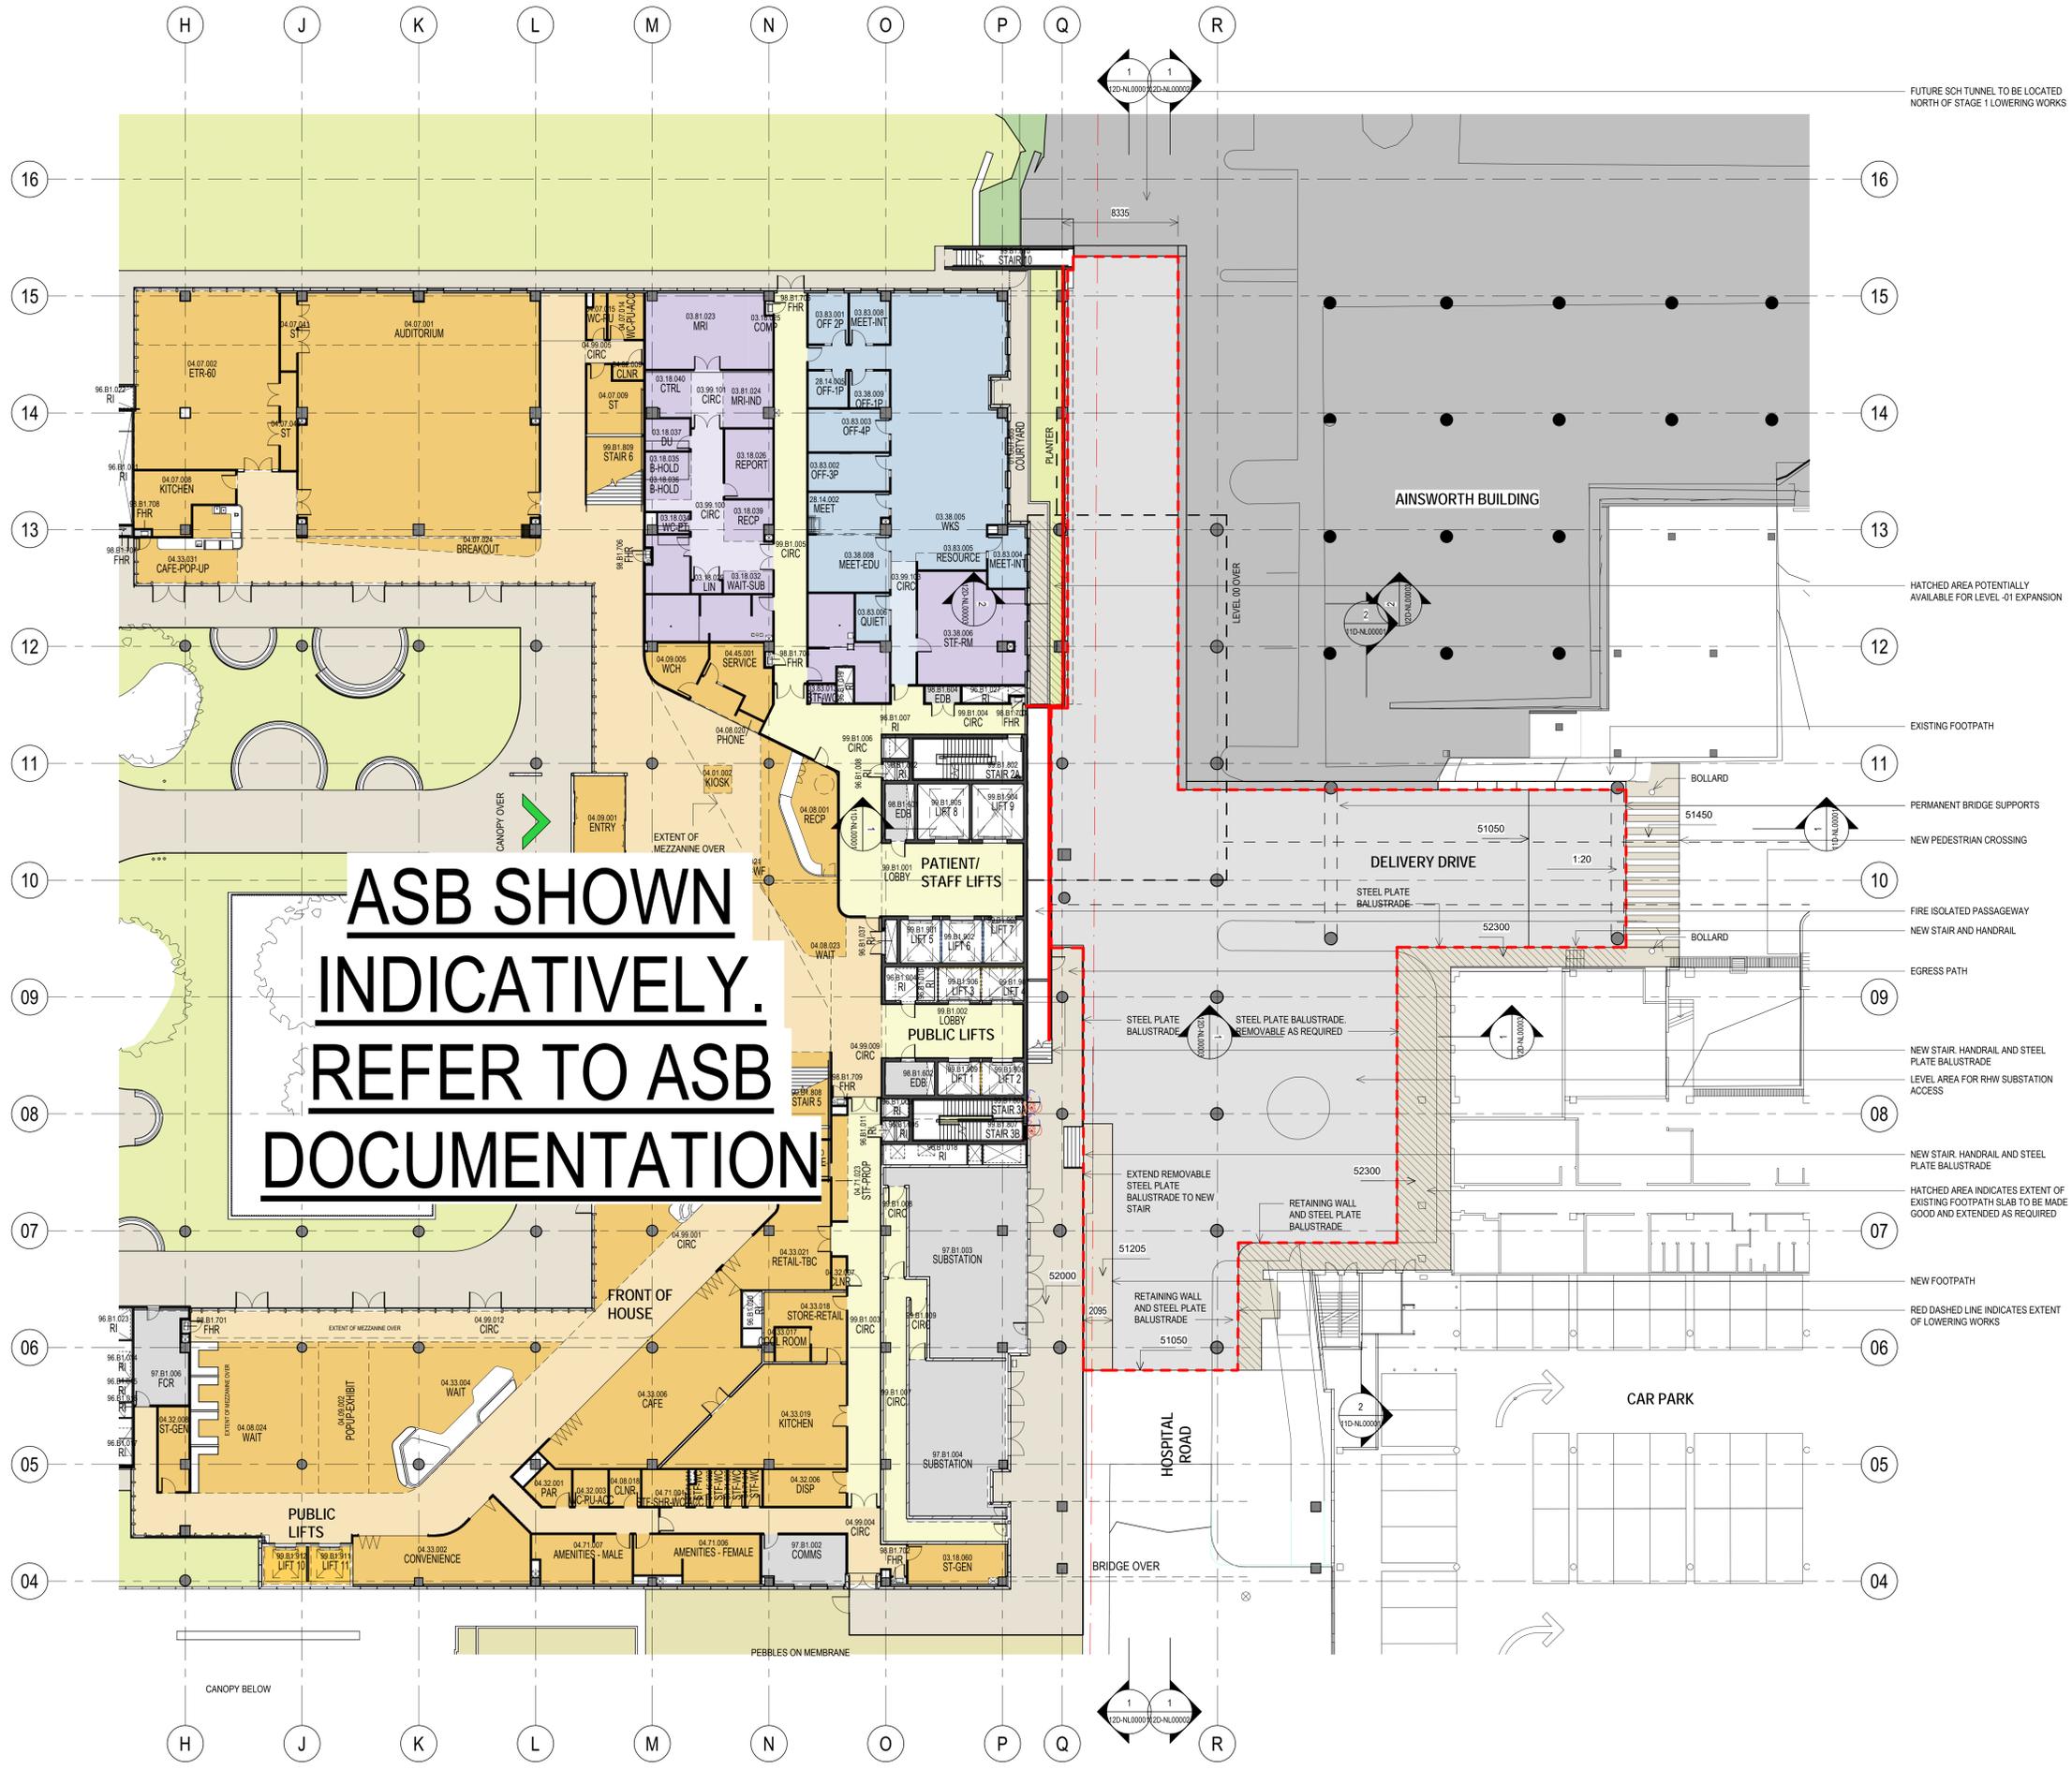
RCR-BVN-ARC-00-DRW-11B-100001
ISSUE A

HOSPITAL ROAD WORKS - LEVEL -01

FUTURE SCH TUNNEL TO BE LOCATED NORTH OF STAGE 1 LOWERING WORKS

HATCHED AREA POTENTIALLY AVAILABLE FOR LEVEL -01 EXPANSION

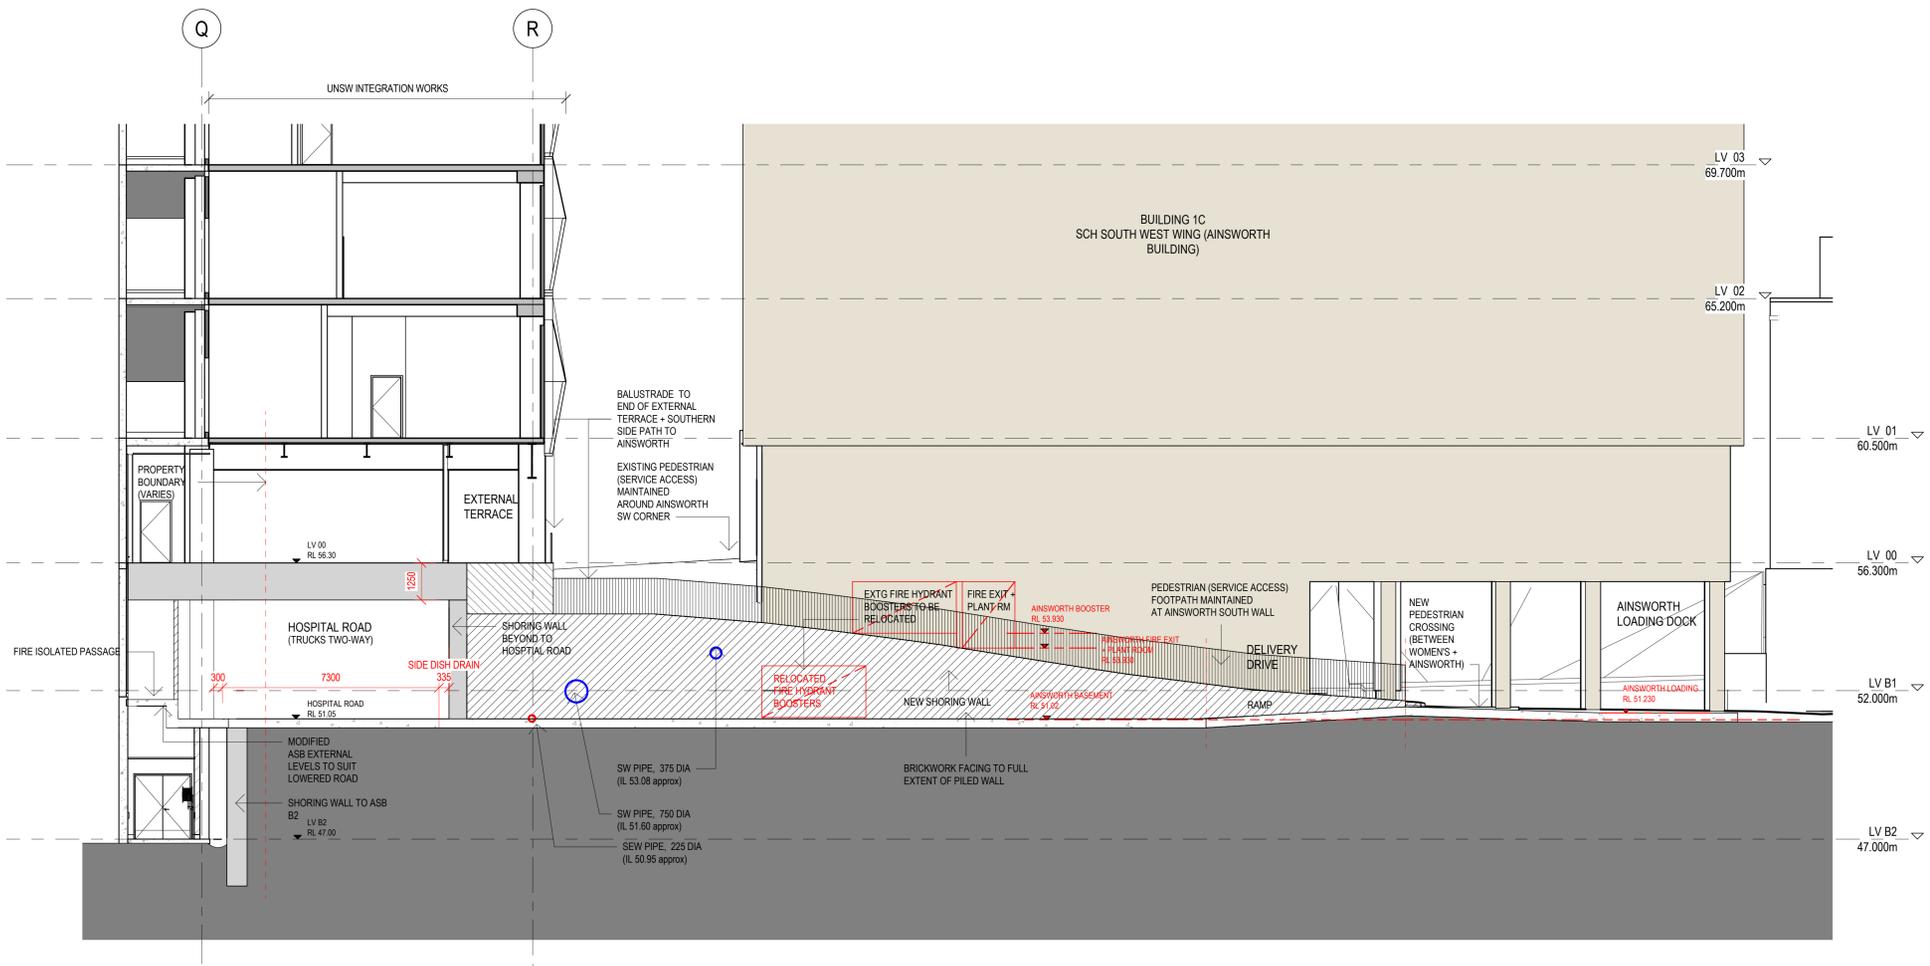
1 HOSPITAL ROAD - SECTION_AINSWORTH SOUTH ELEVATION
1:100

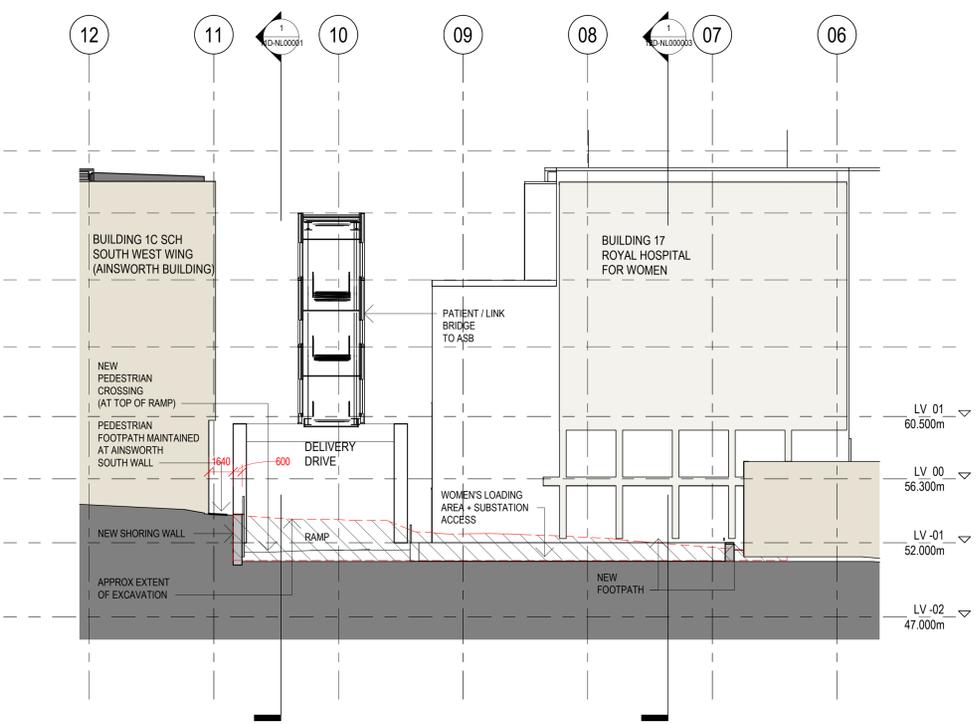
2 DELIVERY DRIVE - SECTION_AINSWORTH + WOMEN'S
1:200
